August 29, 2002

HSA-10/CC-76

In your January 29 letter to Mr. Michael Halladay, you requested the Federal Highway Administration's acceptance of a terminal designed for use with a 3-strand cable guardrail. To support your request, you also sent copies of a Texas Transportation Institute report dated March 2002, entitled "Crash Testing and Evaluation of a New Terminal for Cable/Wire Rope Guardrail," and copies of the crash test videotapes. After staff review of the reported tests, we requested an additional test, NCHRP Report 350 test 3-30. This test was successfully conducted on February 13 and a revised report was sent to Mr. Halladay with your March 6 letter. Based on mutual agreement between our respective staffs, a decision was then made to run a second reverse-direction test (NCHRP Report 350 test 3-39) at an impact point considered to be more critical than that assumed for the original 3-39 test. Significant design changes were made before a successful test was run, the results of which were documented in a separate TTI report, dated August 2002, entitled "NCHRP Report 350 Test 3-39 with 820C Vehicle on the New Cable Terminal."

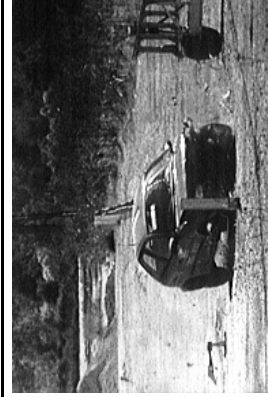
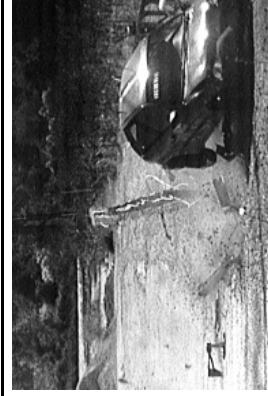
Test Agency Texas Transportation Institute
 Test No. 220502-3
 Date 10/25/01

Type End Treatment
 Name New Terminal For Cable Guardrail
 Installation Length (m) 106.4
 Material or Key Elements Three-Cable Guardrail System Anchored With New Breakaway Steel Posts
 Soil Type and Condition Standard Soil, Dry

Speed (km/h) 102.1
 Angle (deg) 20.0

Dynamic 2.29
 Permanent 2.29
 Working Width 1.82

Exterior
 VDS 11FL3
 CDC 11FLEW3
 Maximum Exterior Vehicle Crush (mm) 300
 Interior
 OCDI FS0002000
 Max. Occ. Compart. Deformation (mm) 34

Summary of results for test 220502-3, NCHRP Report 350 test 3-39.
